Re: Building Permit Application for Exterior Renovation
517 North Broadway Waterfront Improvements

Project Narrative

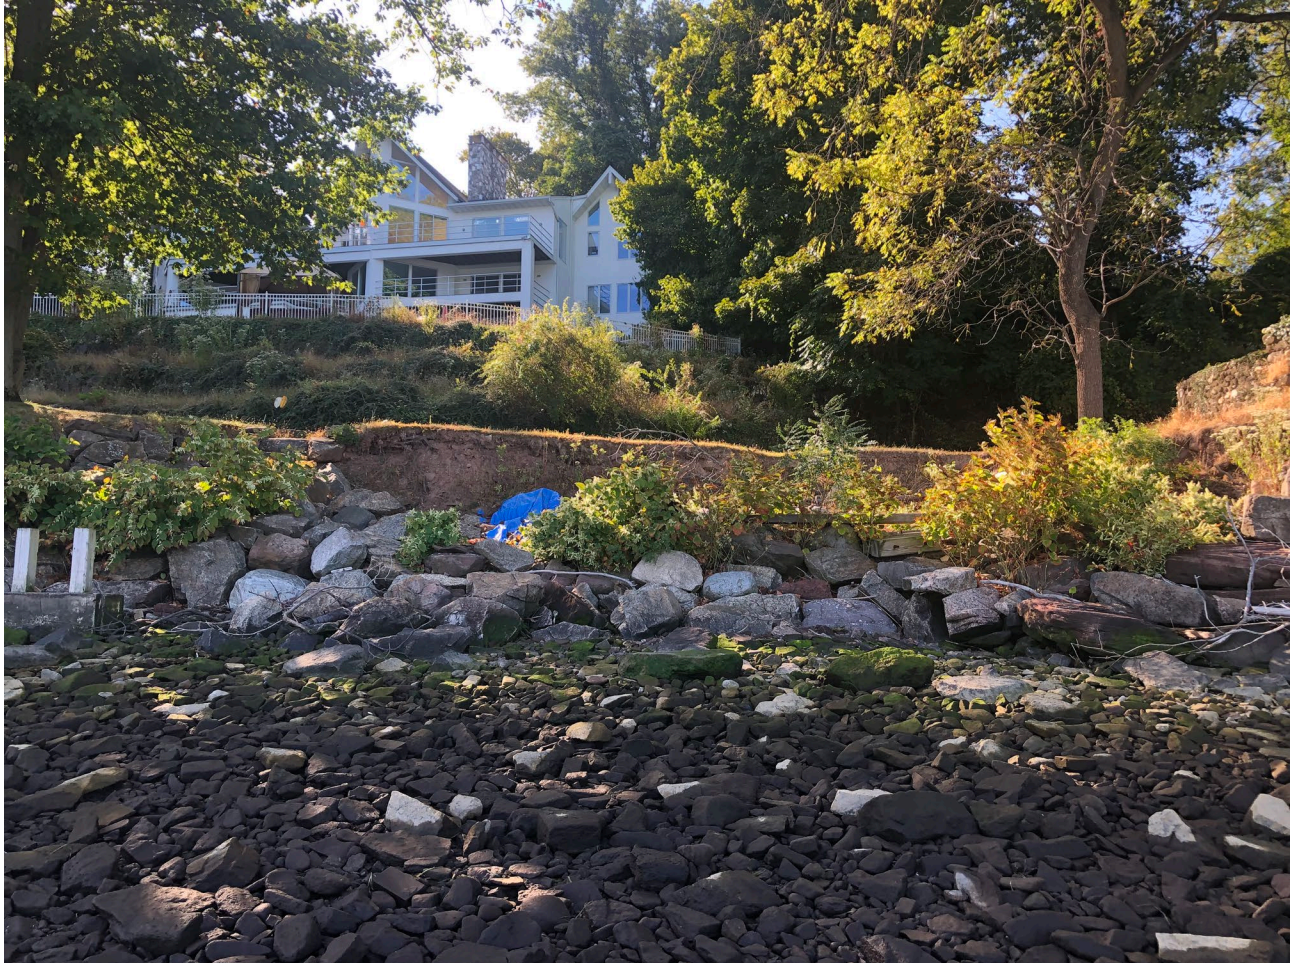
Photograph 1: Eroded seawall to be reconstructed – facing north.

The existing seawall is composed of large stones and is deteriorating along the length of the property shoreline on the Hudson River. Upland settlement and shoreline erosion are apparent, especially along approximately 30 linear feet of seawall extending from the northern edge of the shoreline south to the existing masonry stairs. In this area, the stone seawall has failed and backfill is eroding into the Hudson River (see Photograph 1). This section must be reconstructed to the original footprint of the seawall. The stairs will be reset in coordination with the seawall construction. Continuing south from the stairs, the next 45 linear feet of seawall is proposed to be repointed with the same materials; the seawall is beginning to show signs of erosion and deterioration and maintenance work on the seawall is required now to prevent more intensive and intrusive work later.

If no action is taken regarding the existing stone seawall, the wall will continue to erode, threatening upland stability and erosion control, as well as risking fill entering the Hudson River from a collapsed wall. The proposed work is preventative to ensure continued functionality and safety. Natural hand-laid stone seawalls are dependent upon each of the stones forming a key that supports the entire wall. Loss of larger stones can compromise the entire structure. With existing seawall heights ranging from 5 to 16 feet, a “No Action” alternative may threaten the structural support for the shoreline and earthen slope upland and risk seawall collapse into the Hudson River.

Along approximately 30 linear feet on the northern-most section of seawall, the contractor will rebuild the stone seawall to elevation 5’ (NAVD88). The area behind this section of seawall will be backfilled and sloped to meet the existing grade. The contractor will excavate the soils and materials from behind the seawall and stabilize the slopes prior to reconstructing the seawall. The seawall will be reconstructed from bottom to top, placing the stone in order of largest stones at the base and smaller stones at the top. One tree is in the vicinity of the proposed work and requires removal. Refer to the Site Plan for the location of this tree.
